# CONSERVATION ETHICS TODAY

# ETHICAL CHALLENGES IN THE CONSERVATION OF THE WALL PAINTINGS OF CHAPEL 11 AT THE SACRO MONTE DI VARALLO

**Abstract:** Chapel 11 is one of the 45 chapels of the *Sacro Monte* di Varallo. It is decorated with 16<sup>th</sup> century polychrome terracotta statues and wall paintings representing the Massacre of the Innocents. Since 2015, the University of Applied Sciences and Arts of Southern Switzerland (SUPSI) is in charge of its conservation. Up-close examination of the wall paintings allowed to observe the presence of overpainting, which were evaluated to have no aesthetical and/or technical quality. During the study phase and with preliminary tests for treatment development, it became clear that the removal of this overpaint was risky for the underlying original decoration. Moreover, it was not possible to determine if under the overpainting there was the original layer and in what condition it was. Although IR Reflectography showed the presence of underdrawings, this information did not always coincided with the presence of a paint layer. Considering that the overpainting covers about 80% of the surface, SUPSI strongly advised against embarking on

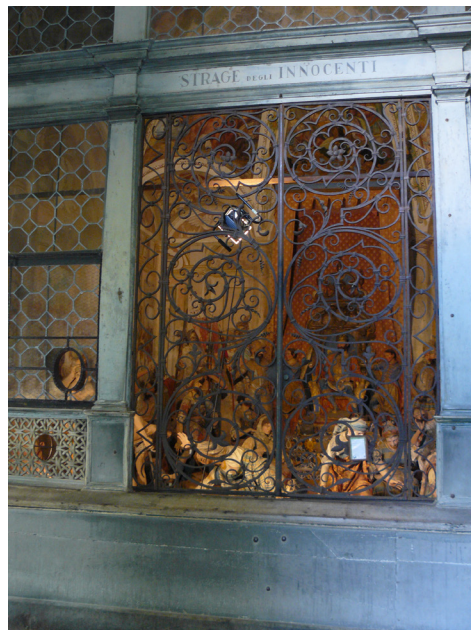
Fig. 2 View of Chapel 11 representing the *Massacre of the Innocents*. Visitors and pilgrims can see the chapel only through this metal grate.

This chapel was built on an initial project by Galeazzo Alessi (*Book of Mysteries* 1565-1569) under the patronage of the Duke of Savoy Carlo Emanuele I. The construction began in 1586 with the supervision of the brothers d'Enrico from Alagna (a nearby village). The walls were painted in 1590 by Giovanni Battista della Rovere and his younger brother Giovanni Mauro (better known as the *Fiamminghini* brothers). They were talented and requested painters, very active between the 16<sup>th</sup> and 17<sup>th</sup> centuries, authors of decorating cycles in several important churches in the north of Italy and many chapels of the Sacro Monte in Orta.<sup>4</sup> The terracotta statues were made in 1591 by Michelangelo Prestinari, an artist working at the Cathedral in Milan.<sup>5</sup>

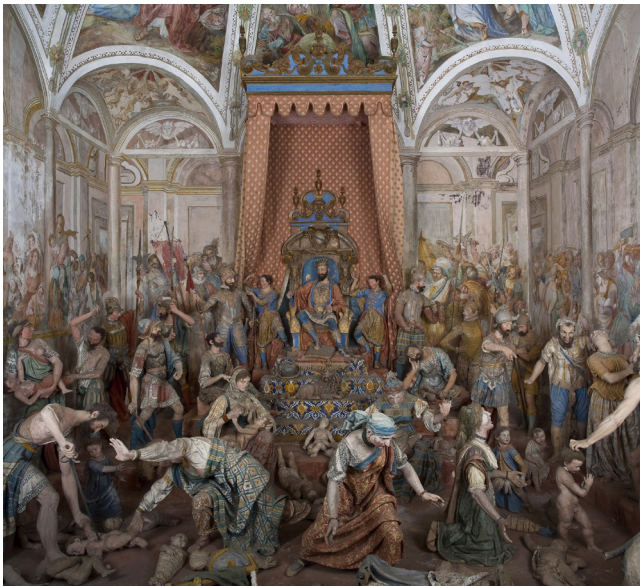
Three years after completion, the Bishop Carlo Bascapé asked the same sculptor, to add 30 statues of massacred children and to modify the throne of Herod (Fig. 3).

Fig. 3 View of interior of Chapel 11.

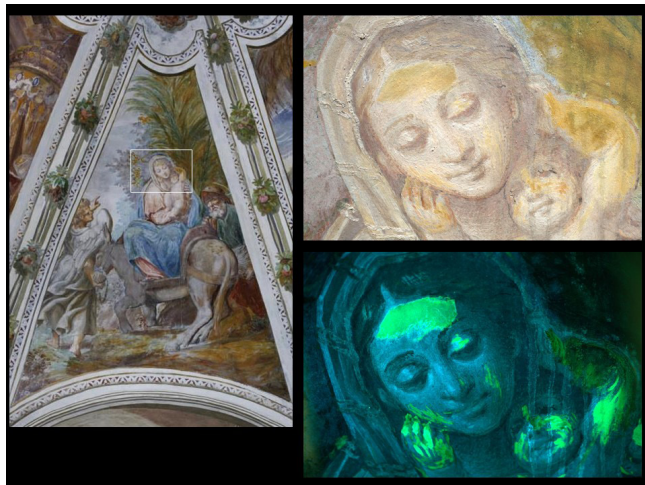
Fig. 4 Portion of wall paintings in the vault of Chapel 11 photographed in visible and UV light. From the scaffolding the heavy and extensive overpainting is clearly visible particularly in UV light due to the high UV induced fluorescence of some of the paint components.

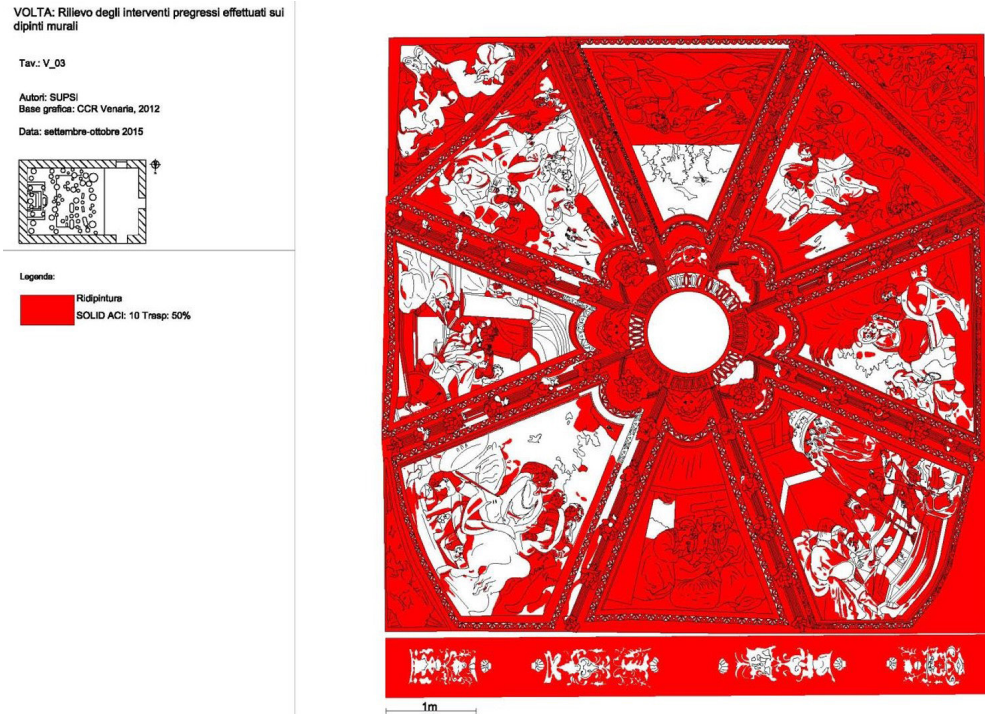
a difficult task considering that over 80% of the surface was covered by overpainting which was often heavy and thick (Fig. 5).

Fig. 5 Visual examination showed that over 80% of the surface was covered by overpainting which was often heavy and thick and is indicated in red in this map.

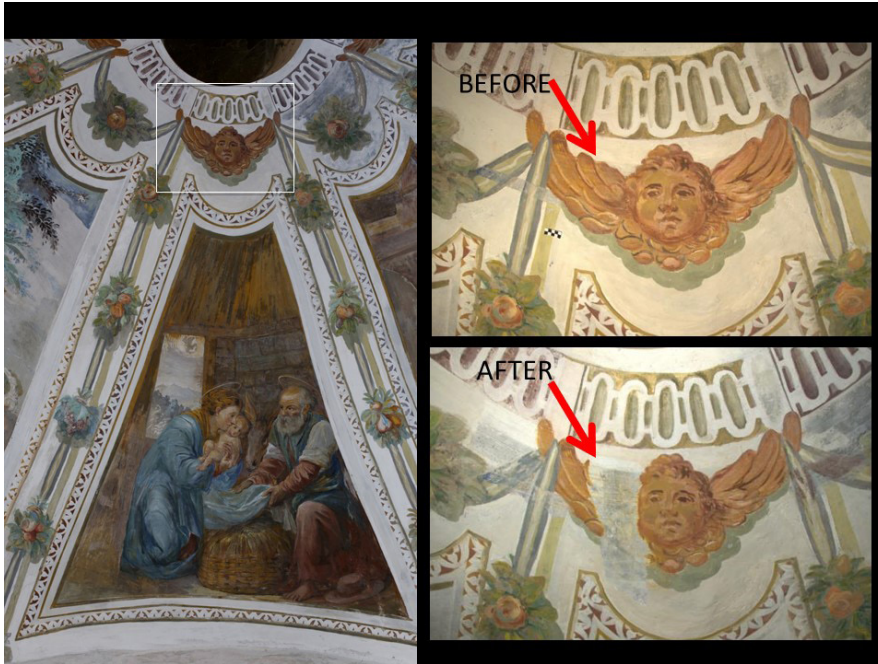
Fig. 6 Overpainting removal test in the architectural portion on the vault. The test revealed that no original paint was present underneath.

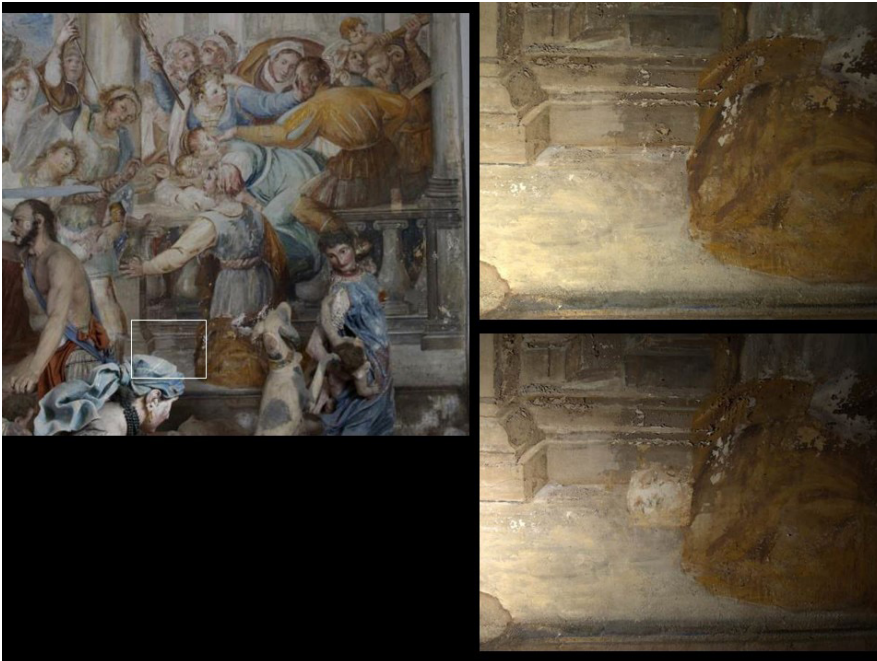
Fig. 7 Overpainting removal test in the architectural portion on the north wall. In this case, the removal of the overpaint revealed the head of a child, which was visible in an historical image.

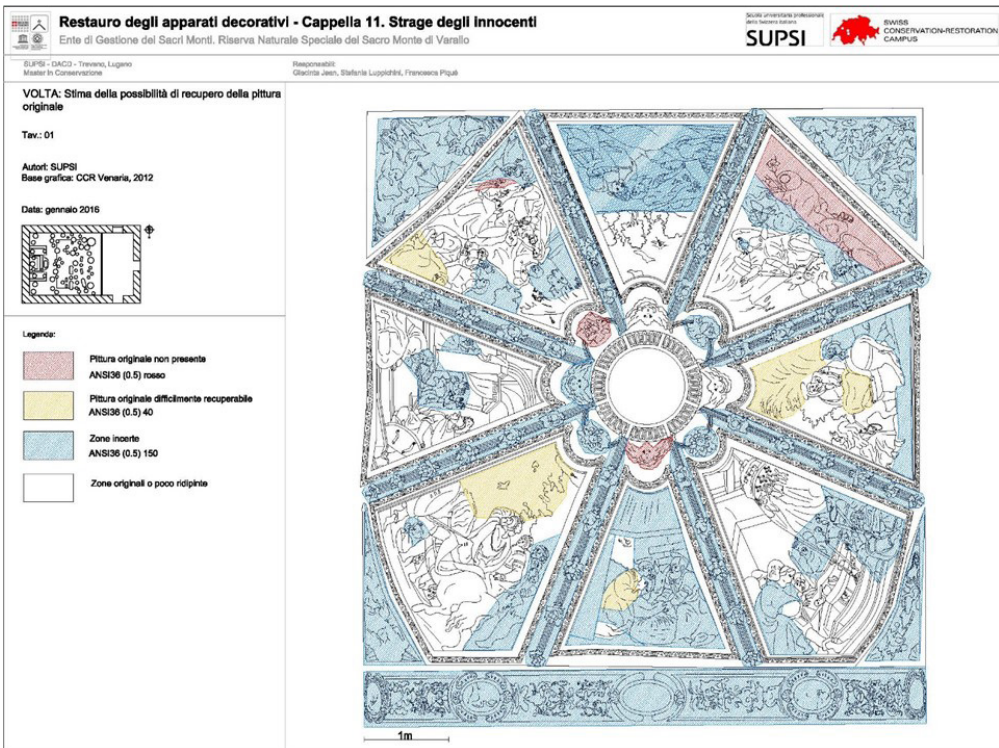
The investigations showed that the stratigraphic situation varies a lot and that it is not possible to predict how much original is under the repainting and of course in which condition it is. The map in Fig. 8 illustrates in blue the areas in which the recovery of the original layer was considered unpredictable.

Fig. 8 The thorough examination of the paintings combined with local overpainting removal tests enable the team to summarize the situation in graphic form. The red areas indicate no original paint; yellow indicate areas where the original paint is present, but it is difficult to recover; while the blue indicates the unpredictable areas. The rest, in white, is where the original paint is visible (no repainting is present).
